# Manhole Inspection Summary

Manhole # S53C\_\_041MH

Insp Date: **6/12/08 3:07 PM**

**Location** Address: **rear 3105 e fairmount ave**

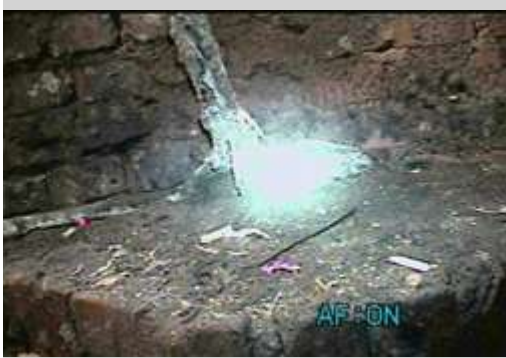
Defect 3

Condition: ☐ Sound ☐ Cracked ☐ Root Intrusion ☐ Deteriorated ☐ Leaks ☒ **Debris**

bench debris

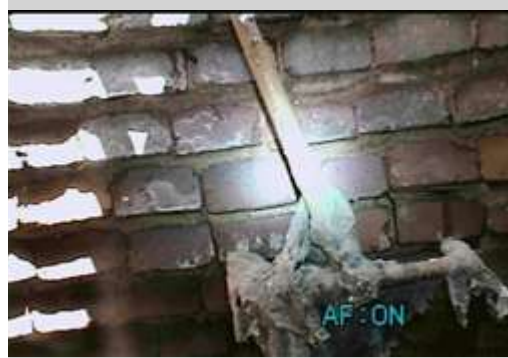
Defect 2

☒ **Evidence Of Surcharge** Depth: **3.2** (ft.) ☐ Active Surcharge Present

surcharge evidence

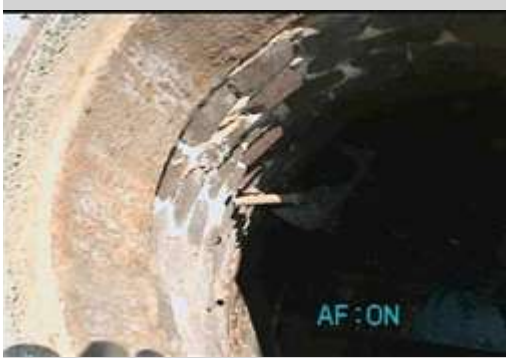
Defect 1

Count: **2** Missing: **1** ☒ **Corroded**

corroded steps

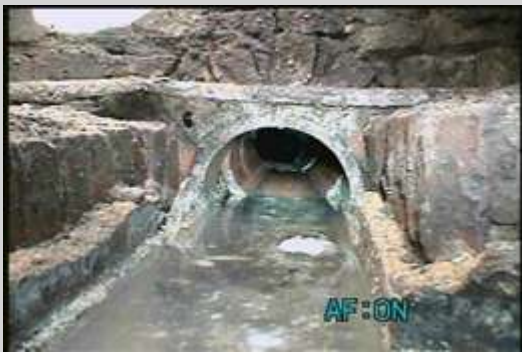
12 O'Clock Outflow

8 in. Circular Gravity Sewer  
Pipe Out @ 12 O'Clock

Invert Depth: **6.59** (ft.) Flow Characteristics: **Slow**

Infiltration: **None** Pipe Seal Cond: **Unknown**

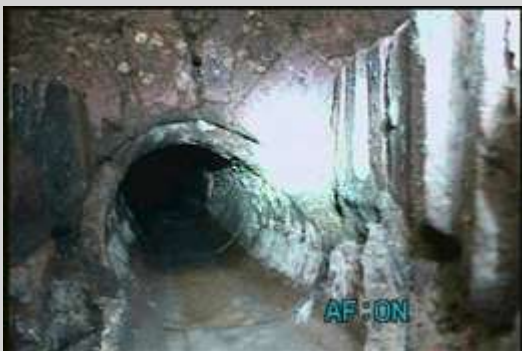
3 O'Clock Inflow

6 in. Circular Gravity Sewer  
Pipe In @ 3 O'Clock

Invert Depth: **6.57** (ft.) Flow Characteristics: **Slow**

Infiltration: **None** Pipe Seal Cond: **Unknown**

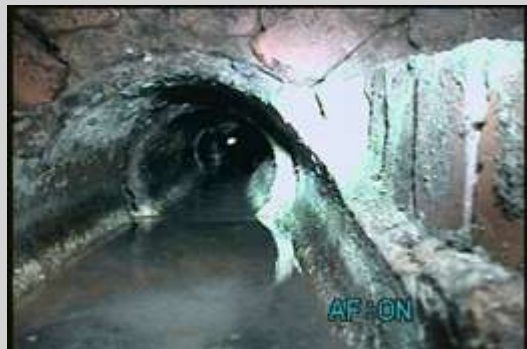
6 O'Clock Inflow

8 in. Circular Gravity Sewer  
Pipe In @ 6 O'Clock

Invert Depth: **6.54** (ft.) Flow Characteristics: **Slow**

Infiltration: **None** Pipe Seal Cond: **Unknown**
